MOBILE OFFSHORE DRILLING UNIT (MODU) OCEAN RANGER,
O.N. 615641, CAPSIZING AND SINKING IN THE ATLANTIC
OCEAN ON 15 FEBRUARY 1982 WITH MULTIPLE LOSS OF LIFE

1. Report No. USCG 0001 HQS 82		2. Government Accession No. AD-A140 910		3. Recipient's Catalog No.	
4. Title and Subtitle Marine Casualty Report Mobile Offshore Drilling Unit (MODU) OCEAN RANGER, O.N 615641, Capsizing and Sinking in the Atlantic Ocean on 15 February 1982 with multiple loss of life				5. Report Date 20 May 1983

**REPORT OF THE U.S. COAST GUARD
MARINE BOARD OF INVESTIGATION CONCERNING
THE MODU OCEAN RANGER, O.N. 615641;
CAPSIZING AND SINKING IN THE ATLANTIC OCEAN
ON 15 FEBRUARY 1982 WITH MULTIPLE LOSS OF LIFE**

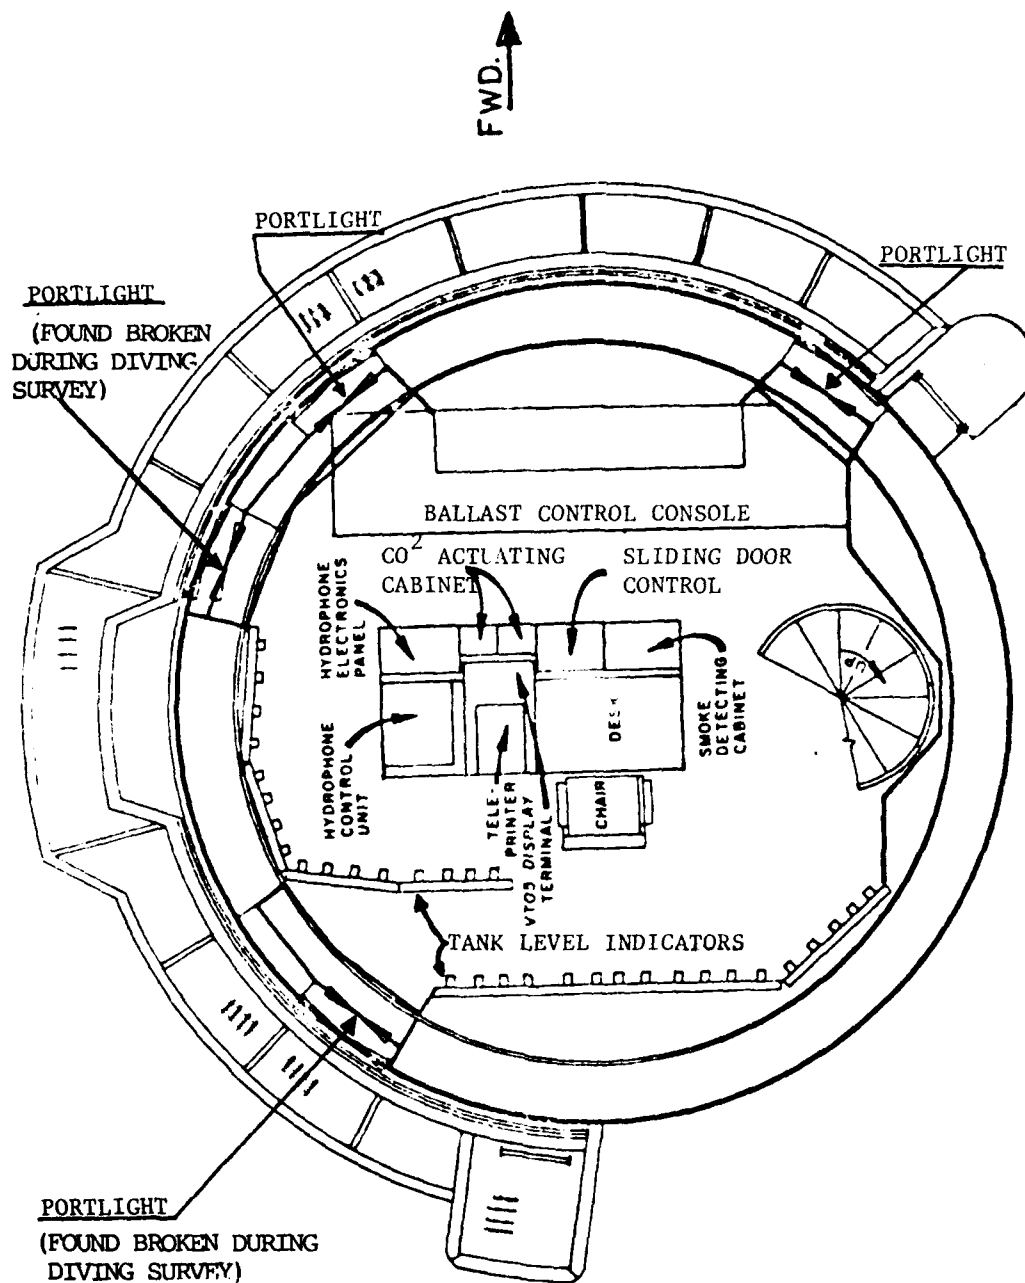
The ballast control room operator was able to view sea conditions and the vessels draft through four portlights¹ installed in the column. The installed portlights were manufactured to standards established by the Japanese Standards Association. Each portlight was permanently installed in the column and could not be opened. Each portlight assembly was made tight by the installation of through bolts around the periphery of the portlight. Post casualty video tapes confirmed that all deadlights had been closed from the inside.² Underwater surveys confirmed that the two portlights located on the portside of the ballast control room were broken (Please see Figure 9).

b. Physical examination confirmed the accuracy of prior video tapes in that two of the four portlights were in fact broken. (Please see figure 9 for the location of the broken portlights.)

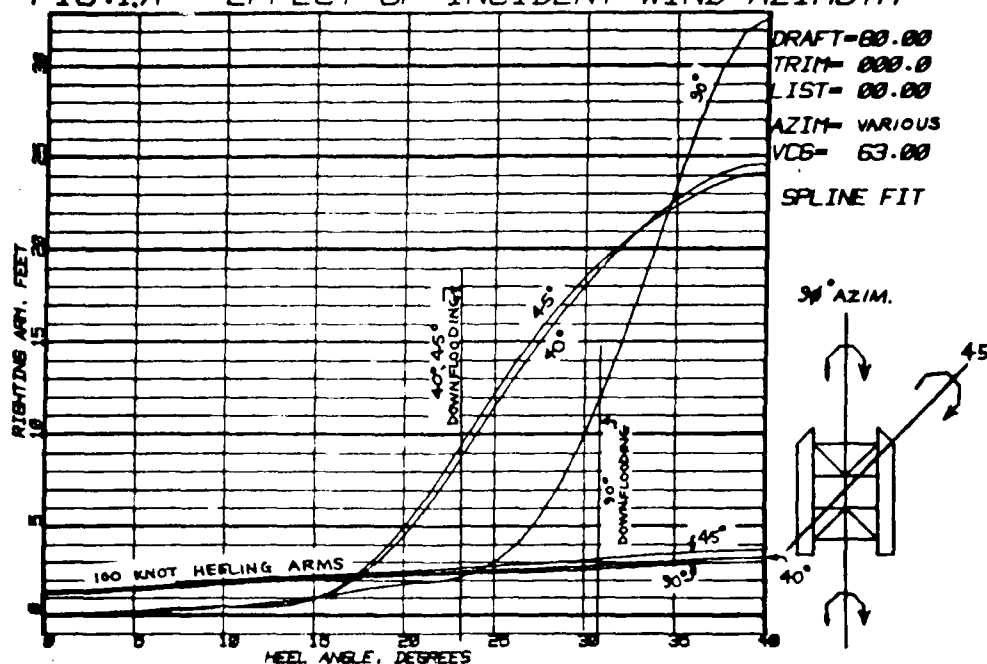
FIG.I.A - EFFECT OF INCIDENT WIND AZIMUTH

Task I.a - Vary wind direction. Make checks with wind 40° and 90° off the port bow.

(3) Since the 45° axis was the critical stability axis, it was used throughout this study in lieu of the 40° axis originally specified by the Marine Board. The 40° and 45° diagonal righting arms shown indicate rotation down by the starboard quarter.

(4) The resultant static list angle along the 45° diagonal is 17.5 degrees.

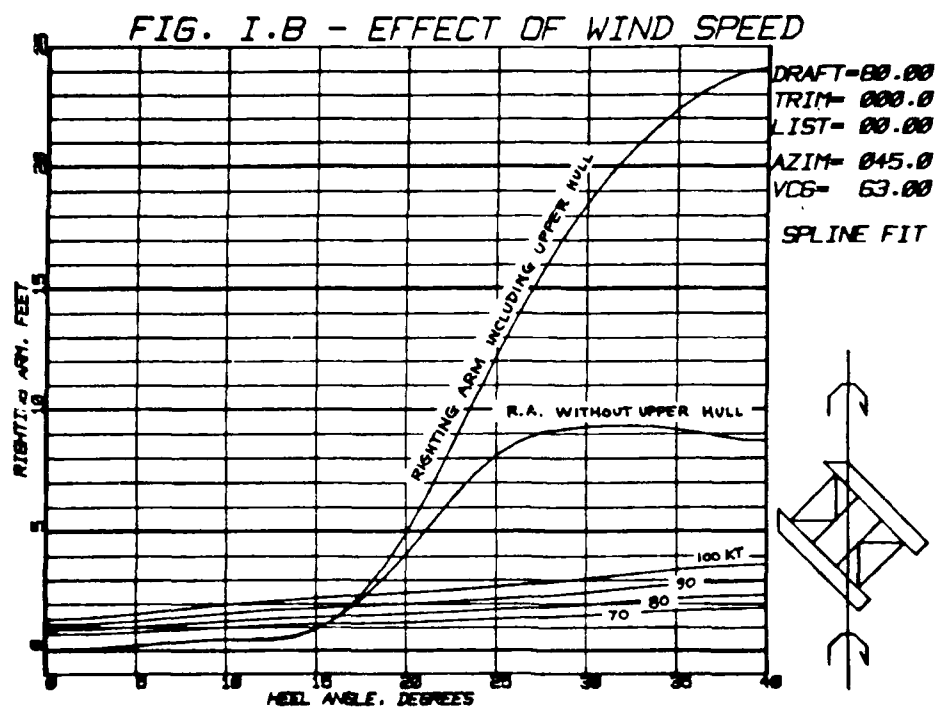
Task I.b - Vary wind speed.

- (1) Wind was from 45° off the port bow.
- (2) Increasing the wind speed from 70 to 100 knots resulted in a 2° increase in static list along the 45° diagonal.

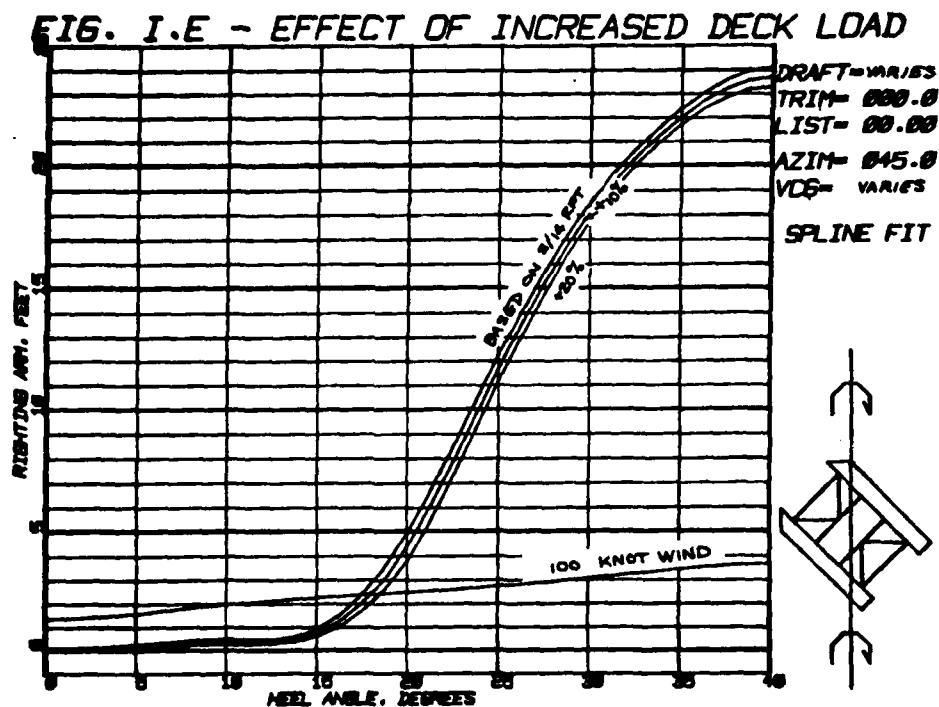
Task 1.e - Deck load increase. Determine righting arms with deck load increased by 10 and 20 percent.

(1) A 20% increase in deck load above that shown on the 2/14/82 morning report resulted in an additional 1.5 degrees in static list on the 45° diagonal under the influence of a 100 knot wind from the port bow.

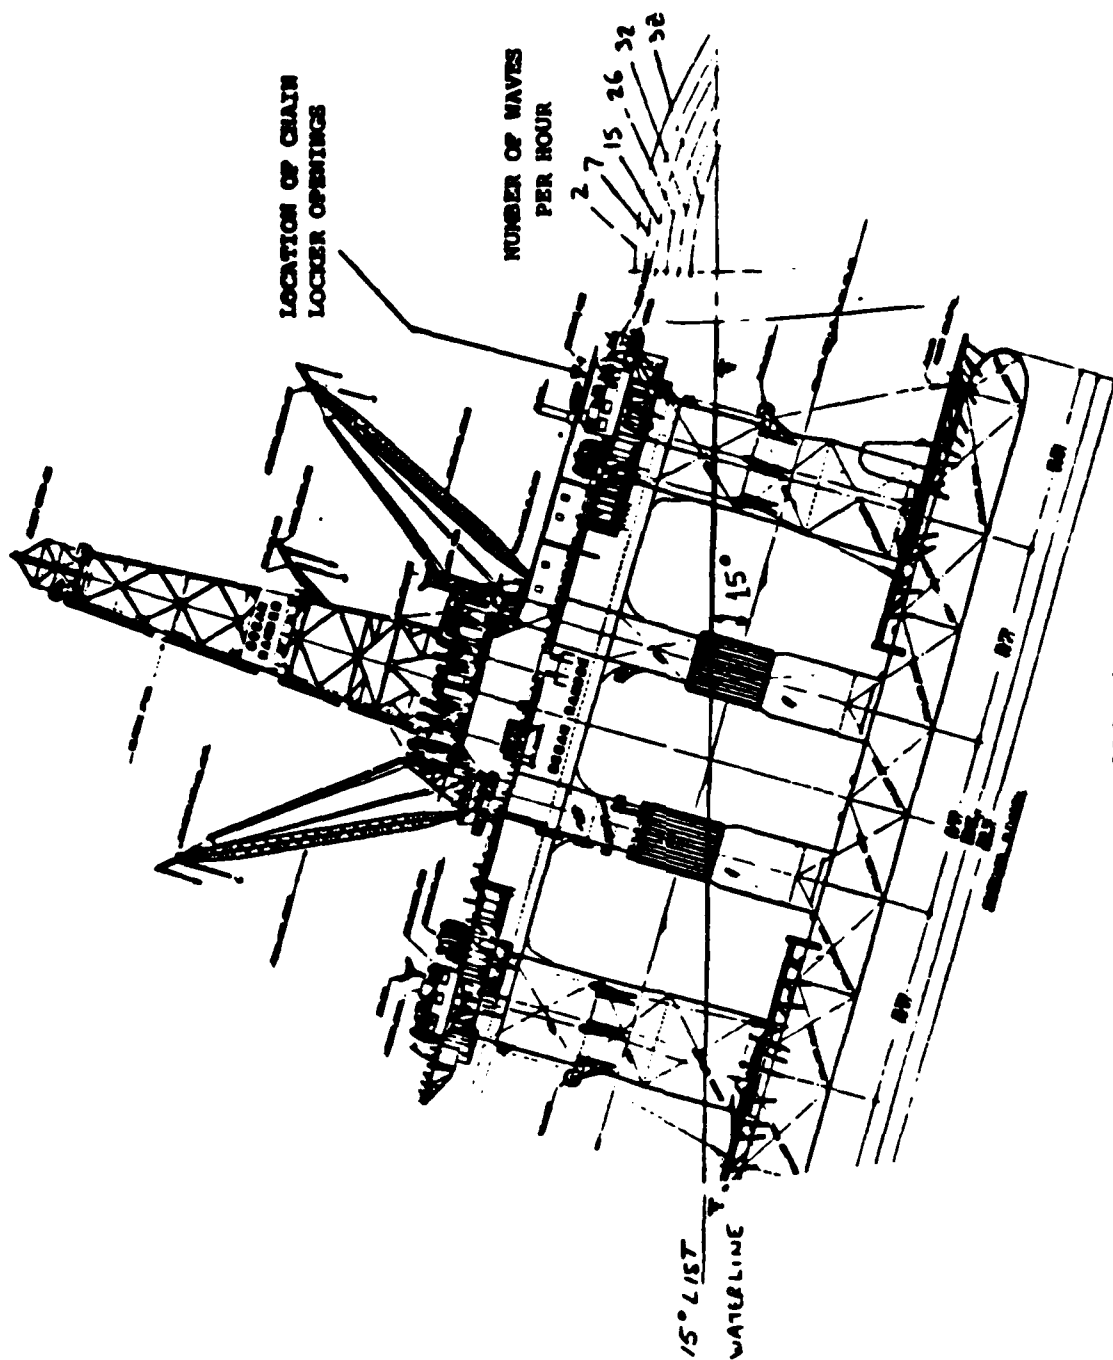
FIG. 4

Figure 4 is a drawing of the OCEAN RANGER at a nominal 15 degree list. The wave heights for the one-third highest waves in a 35 foot significant wave condition have been drawn to scale next to the location of the forward chain lockers.

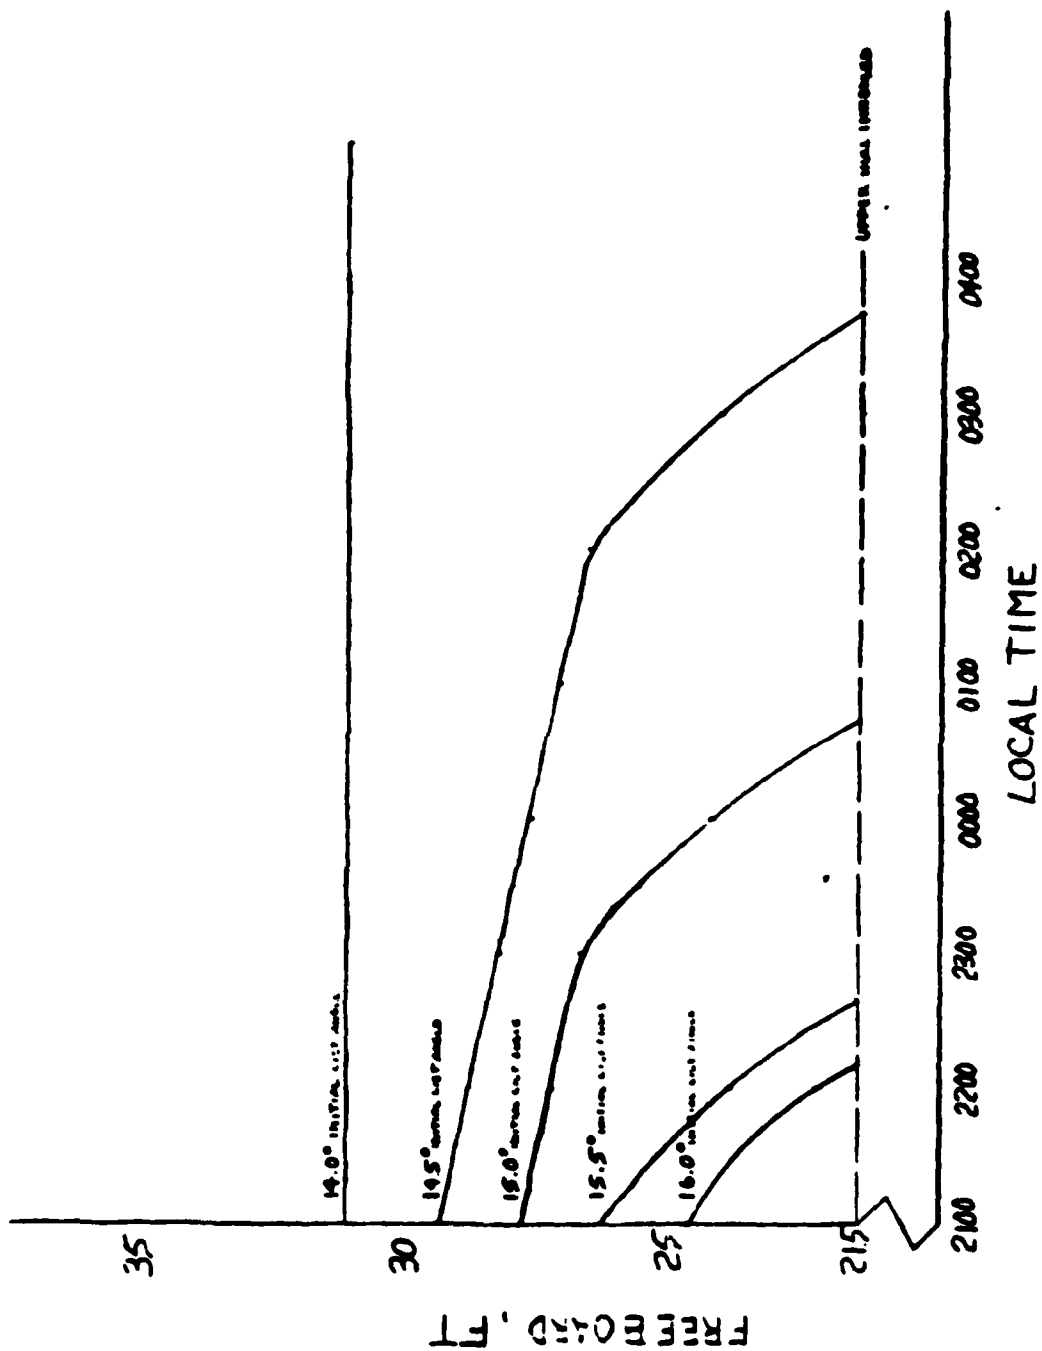
FIG. 5 COMPARISON OF FREEBOARD WITH TIME FOR 80 FEET DRAFT IN A 38 FEET SIGNIFICANT WAVE HEIGHT

Figure 5 graphically shows results of the simulator runs for an 80 foot initial draft in a 35 foot significant wave height condition. Curves have been drawn for each initial list angle.

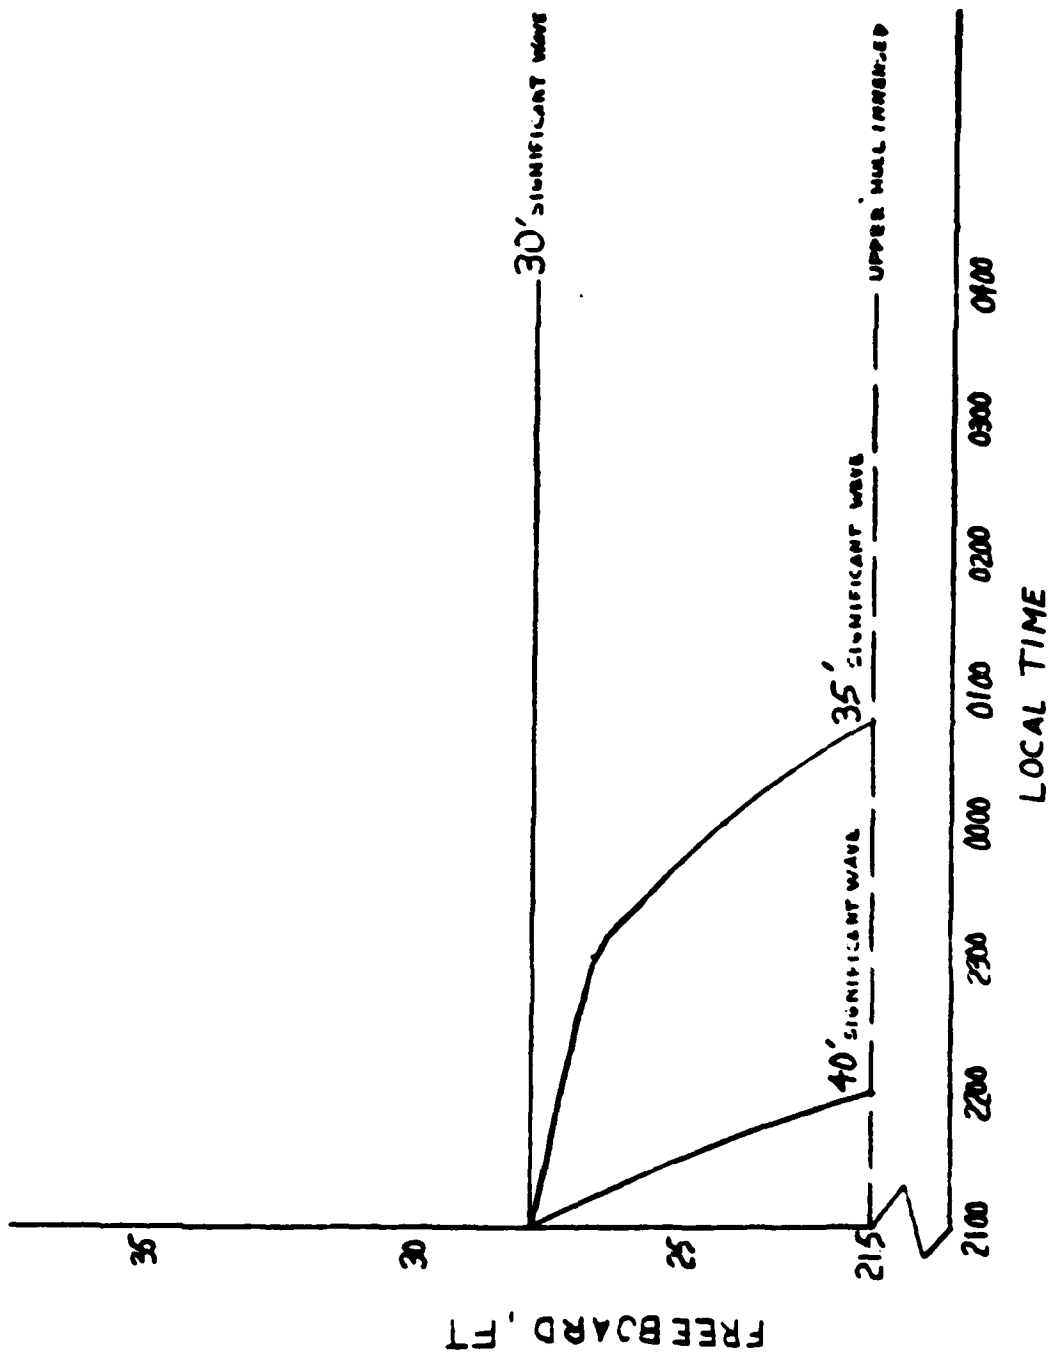
Figure 6 illustrates the sensitivity of the assumed wave conditions on the OCEAN RANGER at an initial draft of 80 feet and initial list of 15 degrees.

FIG. 6
COMPARISON OF FREEBOARD WITH TIME IN THREE DIFFERENT WAVE
CONDITIONS AT A 15 DEGREE INITIAL LIST ANGLE

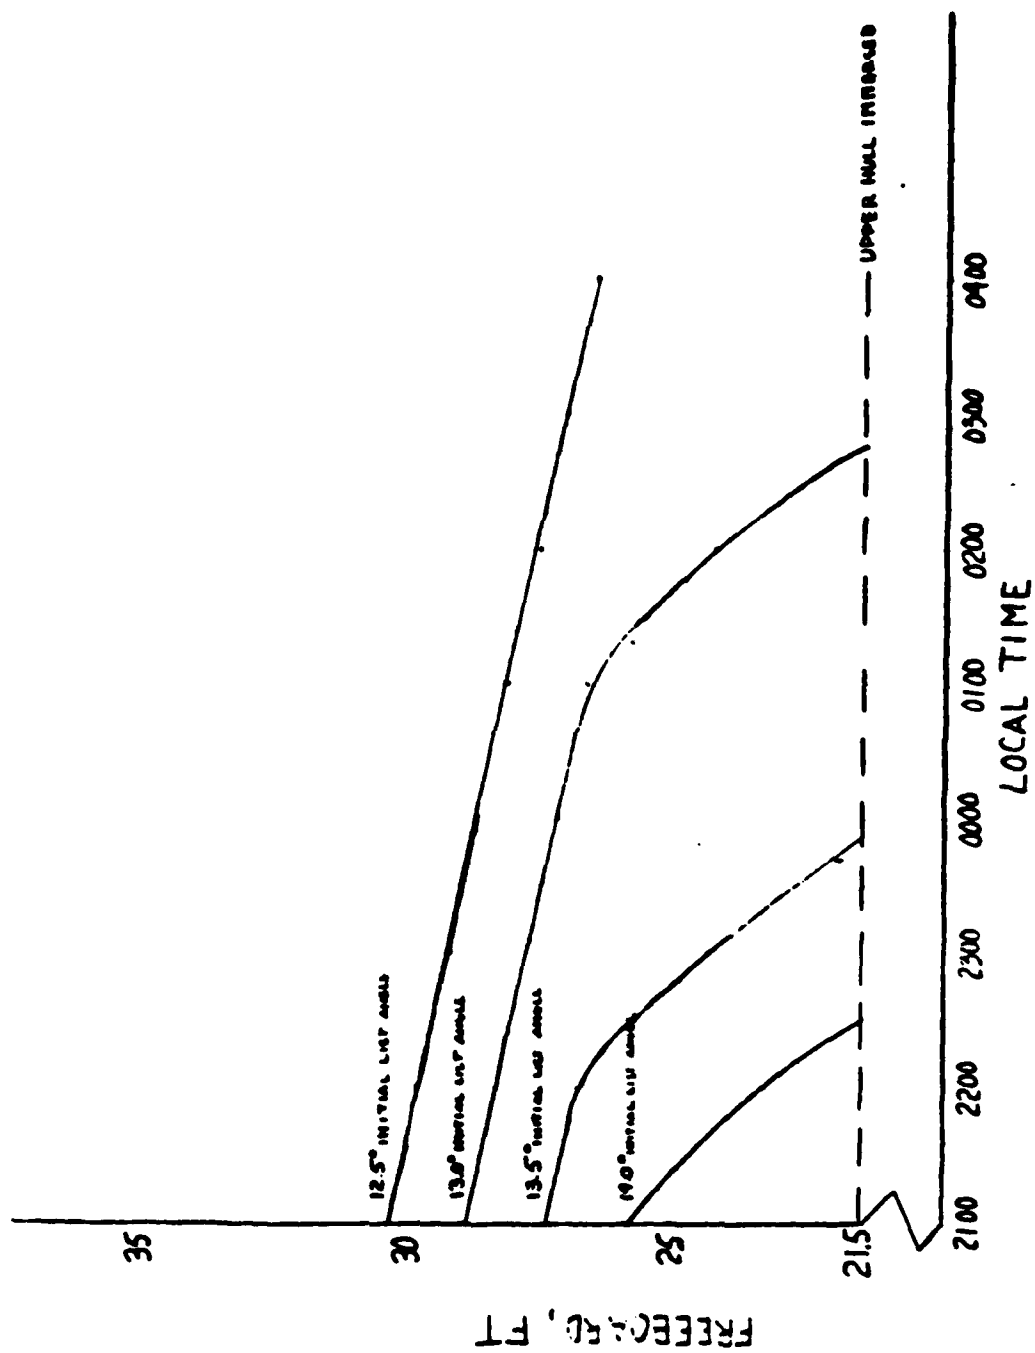
Figure 7 is similar to Figure 5, but with an initial draft of 85 feet rather than 80 feet.

FIG. 7 COMPARISON OF FREEBOARD WITH TIME FOR 85 FEET DRAFT IN A 33 FEET SIGNIFICANT WAVE HEIGHT

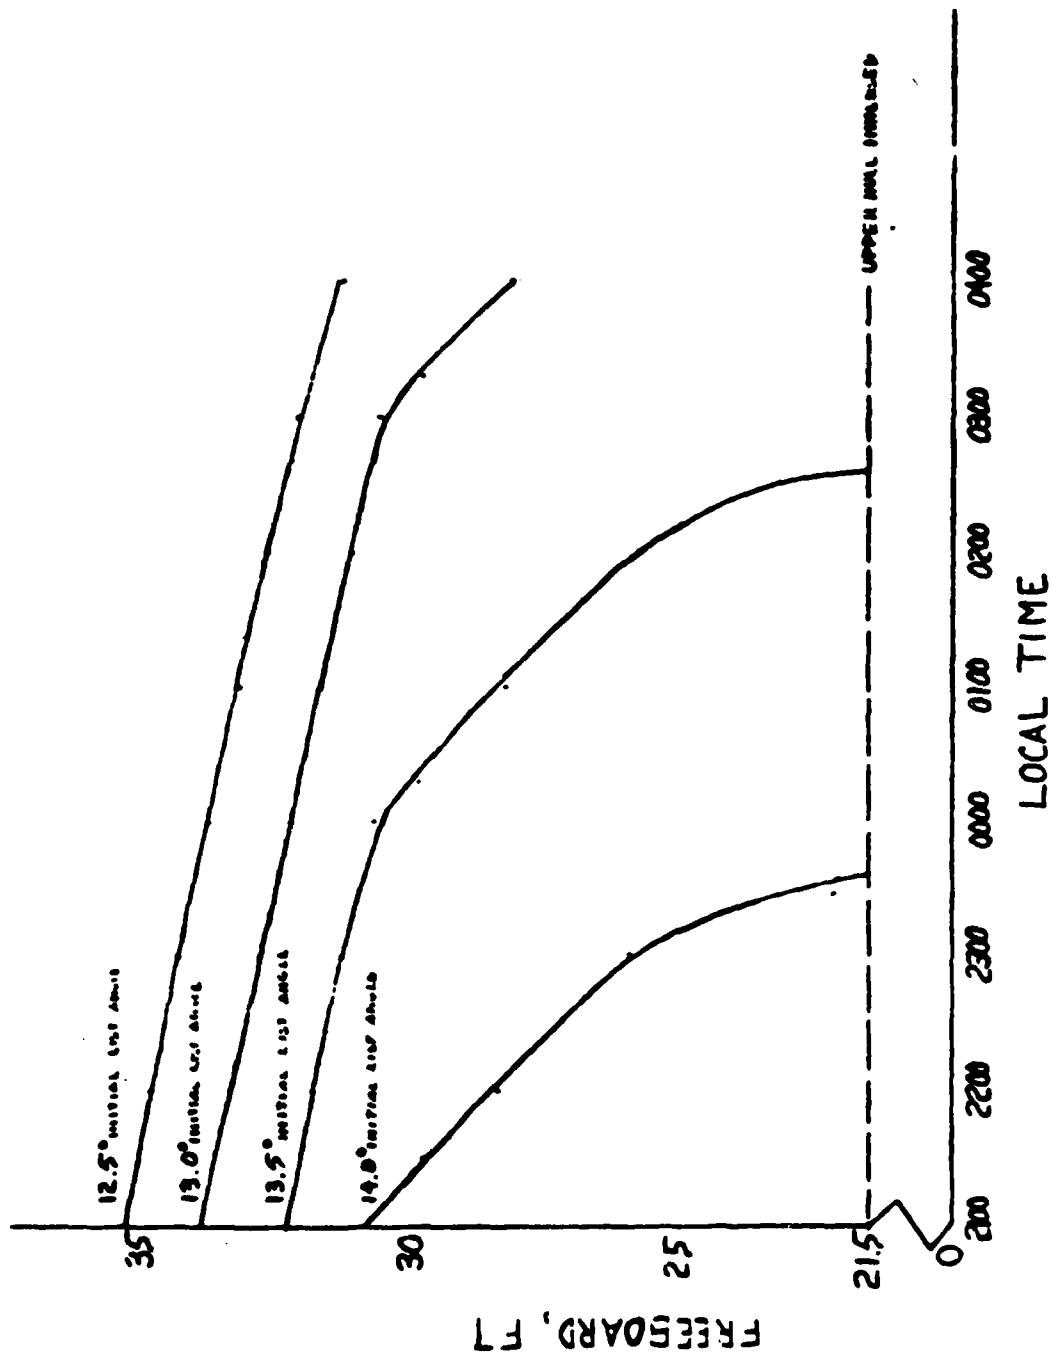
Figure 8 is similar to Figure 5, but with a 40 foot significant wave height rather than 35 feet

FIG. 8 COMPARISON OF FREEBOARD WITH TIME FOR 80 FEET DRAFT IN A 40 FEET SIGNIFICANT WAVE HEIGHT

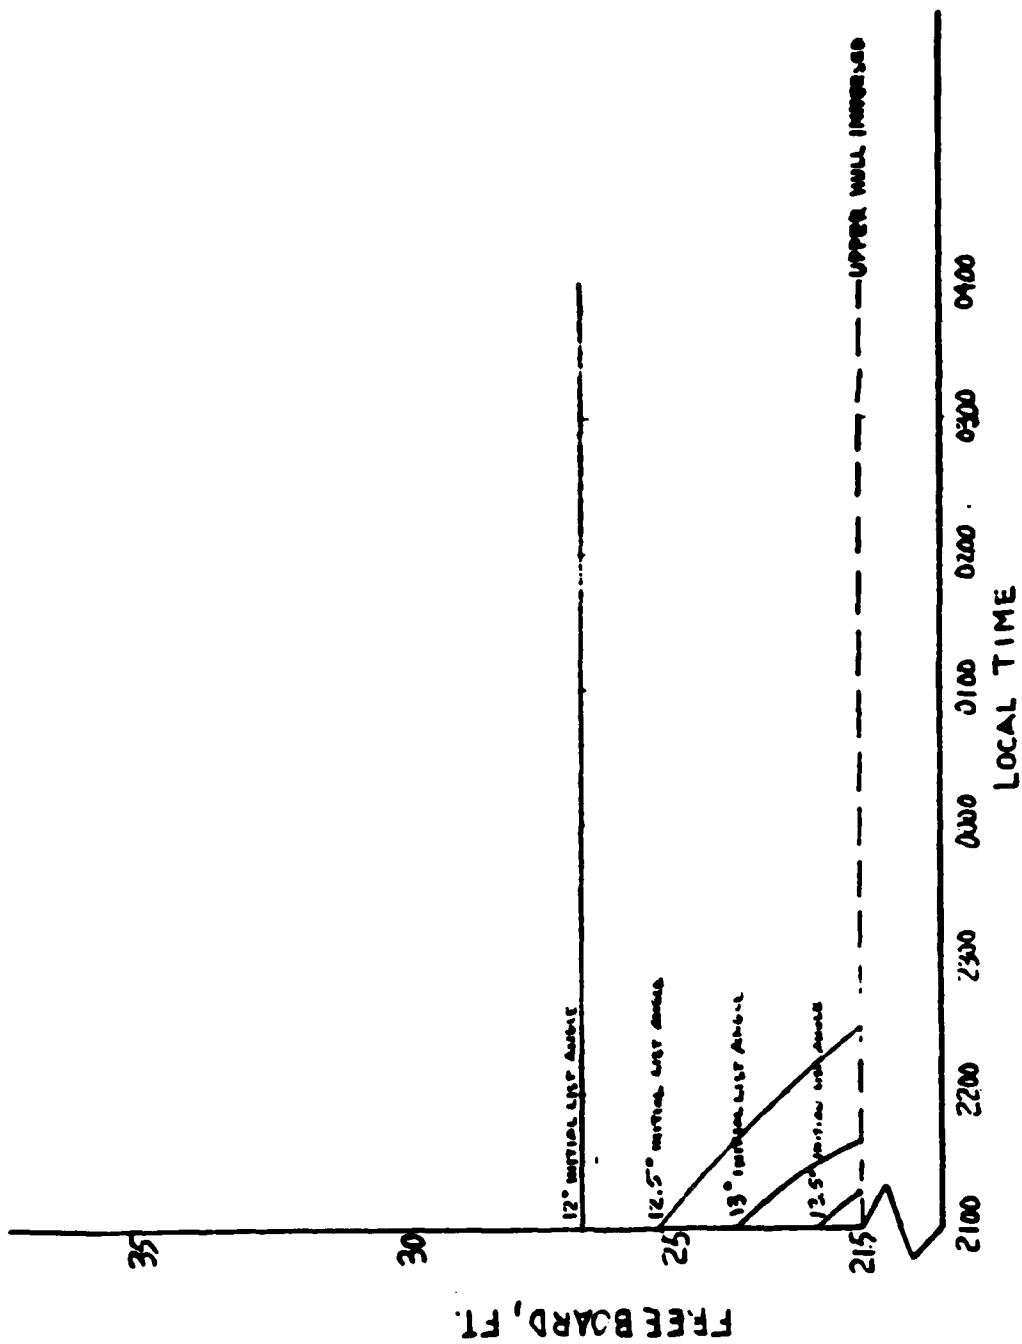
Figure 9 is similar to Figures 5 and 7, but with an initial draft of 90 feet.

FIG. 9 COMPARISON OF FREEBOARD WITH TIME FOR 90 FEET DRAFT IN A 35- FEET SIGNIFICANT WAVE HEIGHT

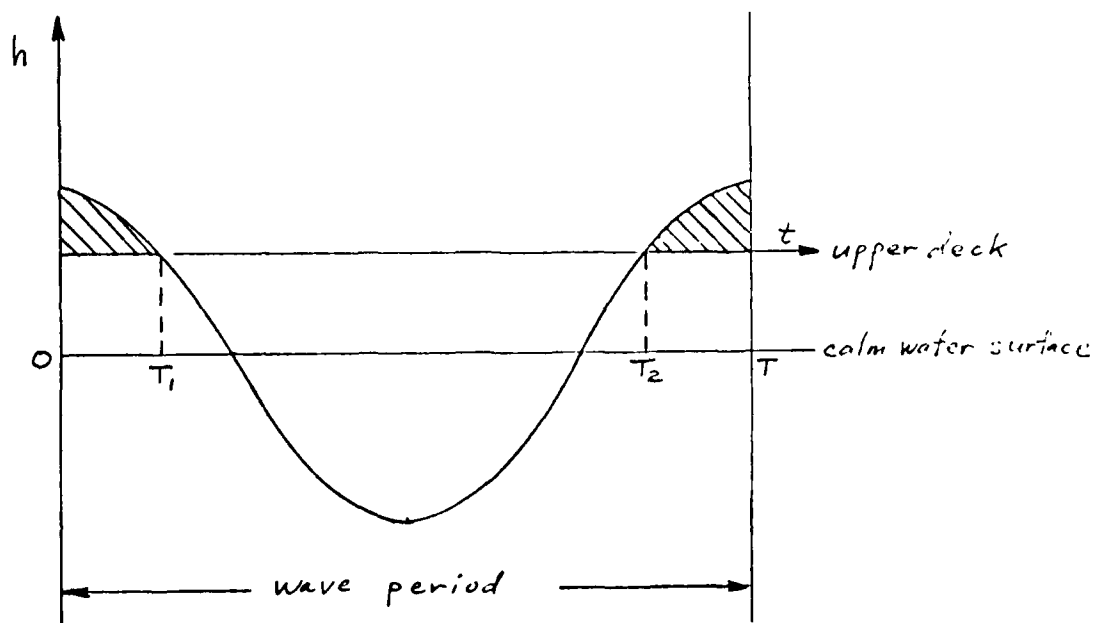
Figure 4 - Sketch of Area Integrated to Obtain Total Flow Rate

The value of h in equation (7') varies over a wave cycle in accordance with equation (5). This is shown graphically in Figure 4. The integration of $\sqrt{2gh}$ over $0-T_1$ and T_2-T is the total flow rate per unit area per wave cycle (Q').

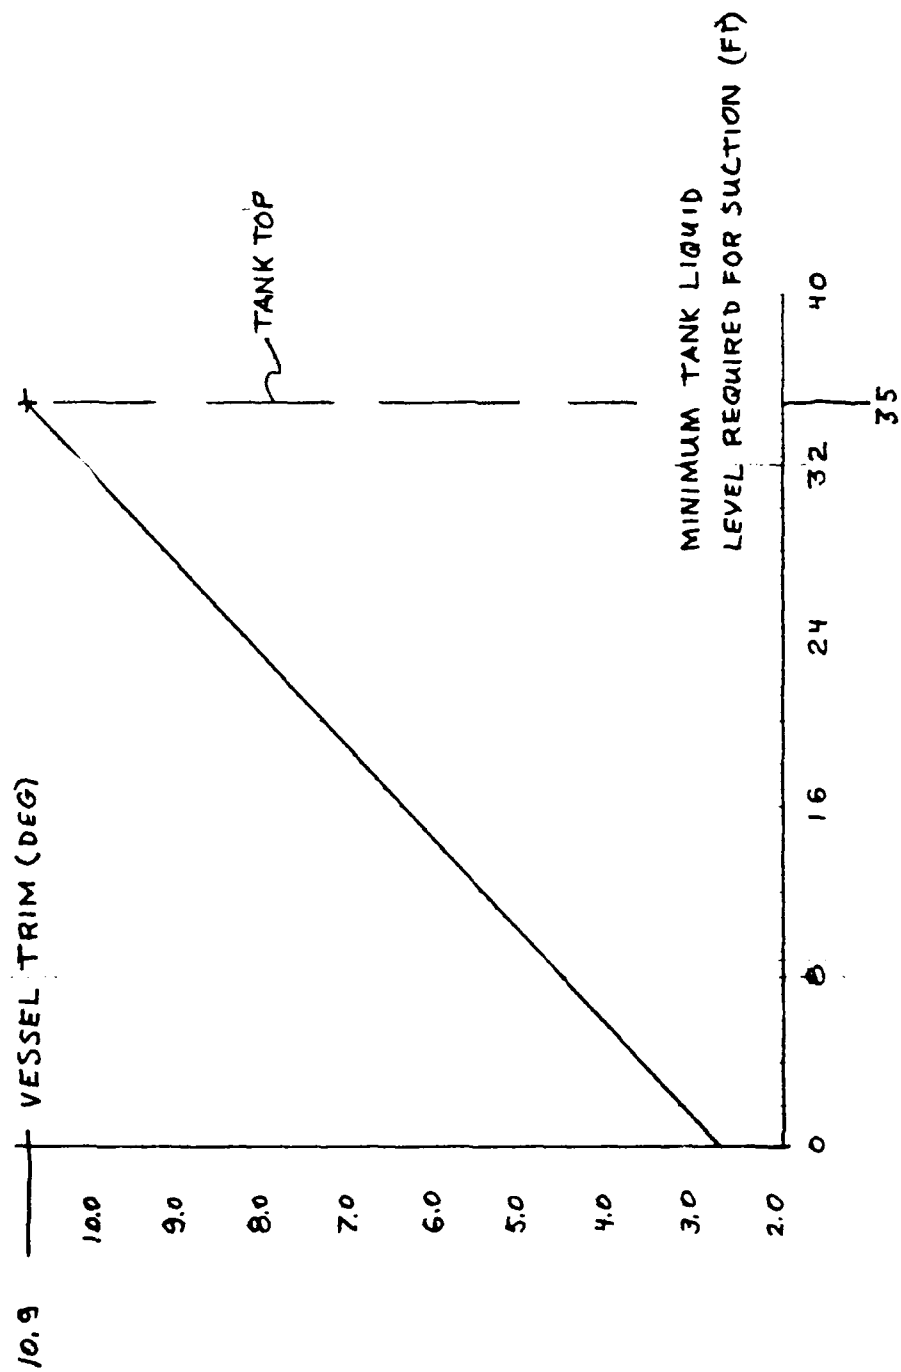
FIG. 2

Case 7. As long as the ballast pump(s) is lined up only on tanks 2 and/or 3 the minimum required tank liquid level to maintain pump suction can be seen from figure 2 as a function of vessel trim.

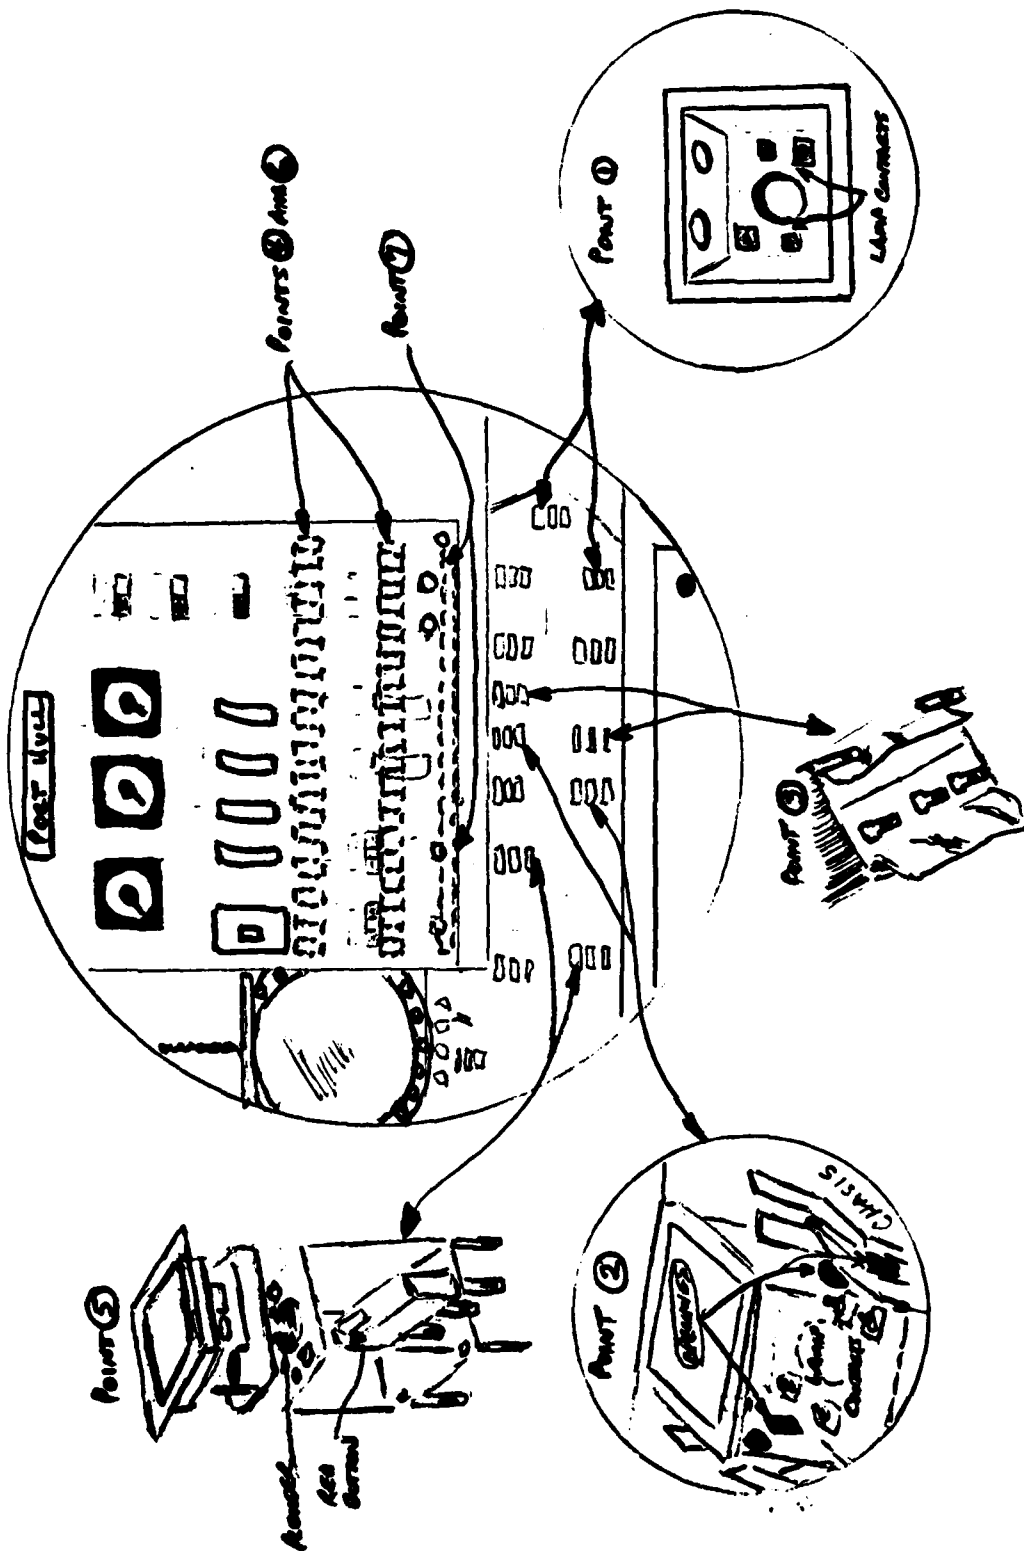
One can visualize a situation where an operator is startled by the changes in indicating lights which are occurring primarily in the port hull section of the console. When some green lights go on while other red lights are dim or out he might quickly conclude that "all valves are opening on the port side". As grounds clear up it would be apparent that not all valves were affected. At that point he would refine his earlier report to "some" valves are opening.

Grounds develop and disappear, some circuits are completed or "bridged". Red indicating lamps would dim or blink off and on for the port and starboard hulls. However some port hull red lights would not re-light because some port ballast valves were actually opening. Some of the port hull green lights might light as the ballast valves completed opening, this would draw the operators attention to the port hull lights to the extent he might not notice that the stbd hull lights were also dimming.
